# 2EZ HS CARRIAGE RETROFIT

**SIMPLIFY MAINTENANCE.  
MAXIMIZE UPTIME.**

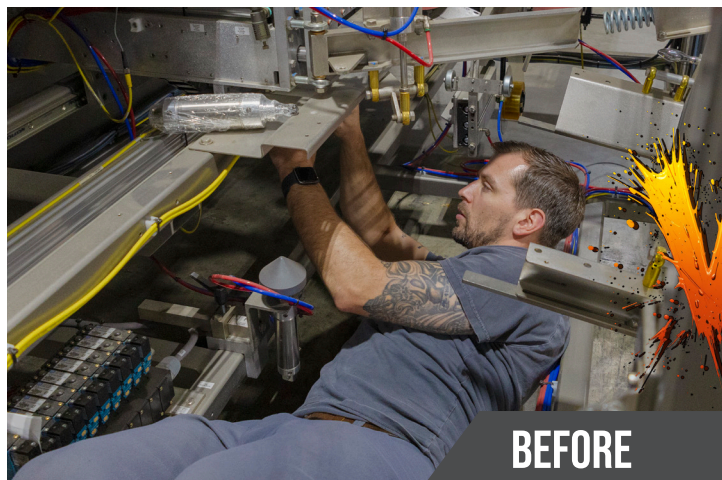
### ❖ LIMITED ACCESS TO COMPONENTS

Critical service components are located within the frame, making routine maintenance more difficult and time consuming.

### ❖ HIDDEN COMPONENTS

Components are hidden from view by the carriage assembly, making it difficult to access and diagnose.

### ❖ CONFINED WORKSPACE

Harder access increases downtime and makes alignment of bearings difficult

### ❖ MORE DOWNTIME

Improper installation and misalignment increase equipment wear, resulting in more frequent repairs, higher parts cost, and downtime.

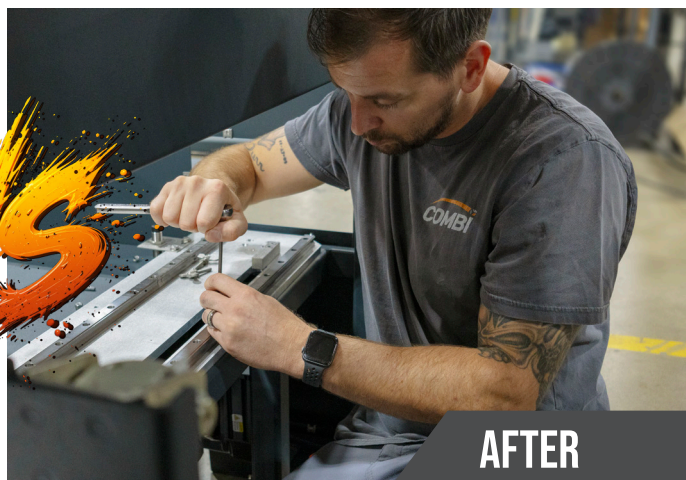
### ❖ EASY, OPEN SERVICE ACCESS

The carriage retrofit makes the bearings accessible from the top, and there is no need to disassemble the carriage assembly.

### ❖ IMPROVED COMPONENT VISIBILITY

The assembly has easy topside visibility making diagnostics easier.

### ❖ PERFECT ALIGNMENT EVERY TIME

Profile rails are bolted onto a machined plate, ensuring that the bearings are aligned every time.

### ❖ EXTENDED EQUIPMENT LIFE

Proper alignment and maintenance adds years to equipment life and reduces costly replacement and repair
